CALIFORNIA PAVEMENT FAULTING STUDY

INTERIM REPORT

MATERIALS AND RESEARCH DEPARTMENT
RESEARCH REPORT
NO. M & R 635167-1

Prepared in Cooperation with the U.S. Department of Transportation, Bureau of Public Roads January, 1970

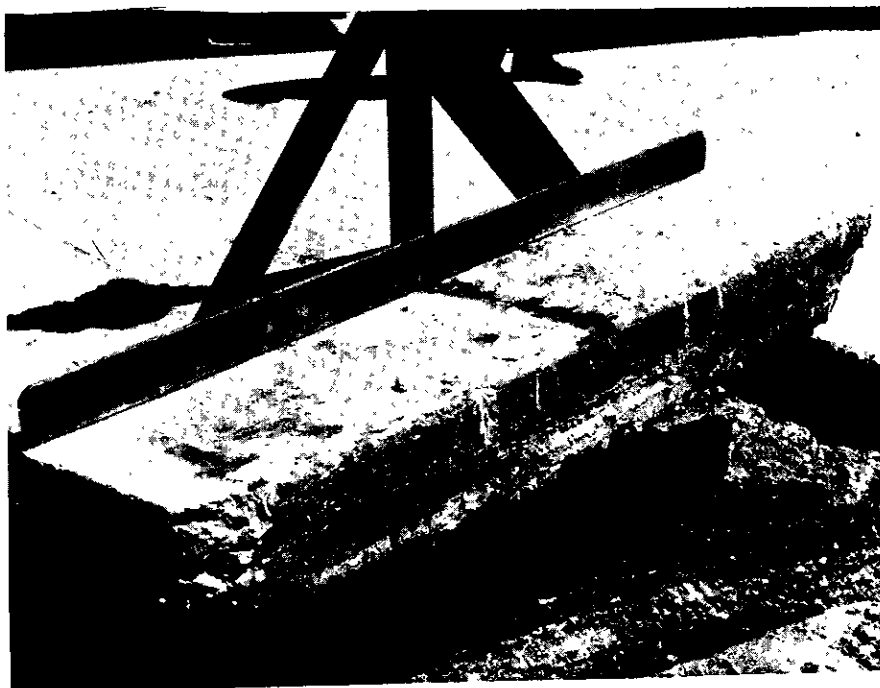
Figure 1

Since this was a new pavement, no significant findings were expected, nor were any found. However, it did serve the valuable purpose of familiarizing field personnel with the techniques of testing and slab removal before moving to locations under traffic. It was noted that there was no evident bond between the CTB and PCC (see Figure 1) and no cracks were found in the CTB. This site may be re-examined in the future, in which case, conditions before and after traffic can be compared.

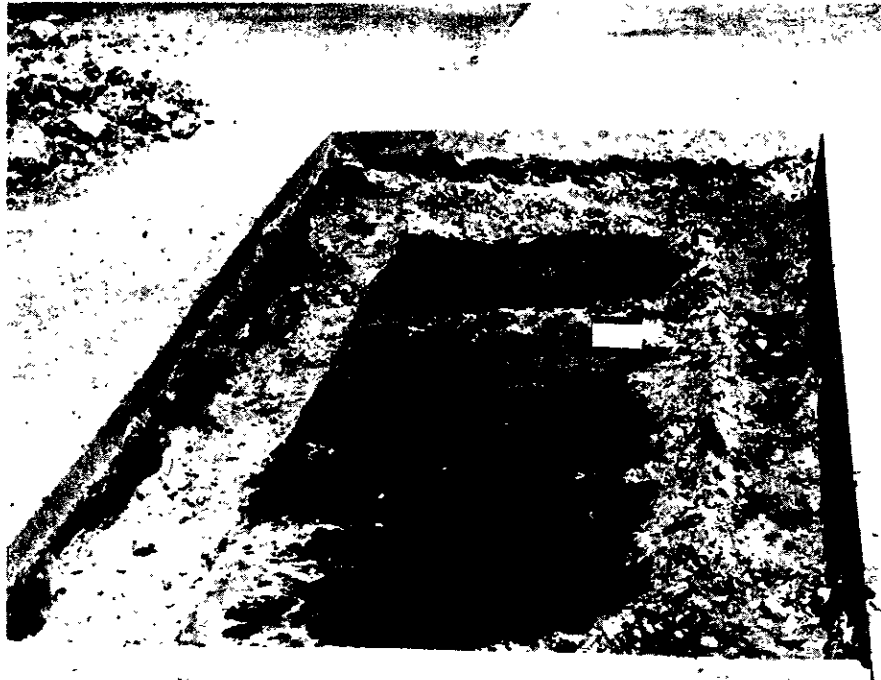
Figure 10

The tracer sands were placed somewhat differently at this location. Pink sand was placed in the shoulder, green sand directly through the joint, and a purple sand under the leave slab 5 feet from the joint and only 6 inches from the crack. Removal of the slab revealed that considerable activity had taken place since the sands were placed. Several particles of the pink sand from the shoulder were found as much as one foot in from the edge of the pavement under both the approach and leave slabs. The green sand placed at the joint was widely scattered in all directions. The purple sand had tended to migrate more toward the shoulder, but some had moved all the way back to the joint, a distance of about 5 feet. The directions of sand movement indicated a circular or swirling water action. The absence of water channels in the exposed surface (Figure 10) might also confirm this type of action. The water movement at this site may not be typical of movement which takes place under uncracked, full length slabs, however.

The layer of granular buildup was quite thick and again extended under both slabs. Petrographic tests on the samples identified the material as having approximately the same composition as the base and shoulders. Some iron fragments and glass beads were found and can reasonably be assumed to

have entered through the joint. (Glass beads are used in traffic striping paint.) Tests indicated the cement content of the loose material to be between 5% and 7%, and that of the CTB as about 3%. There was sufficient strength of the CTB (220 psi) to obtain cores, however.

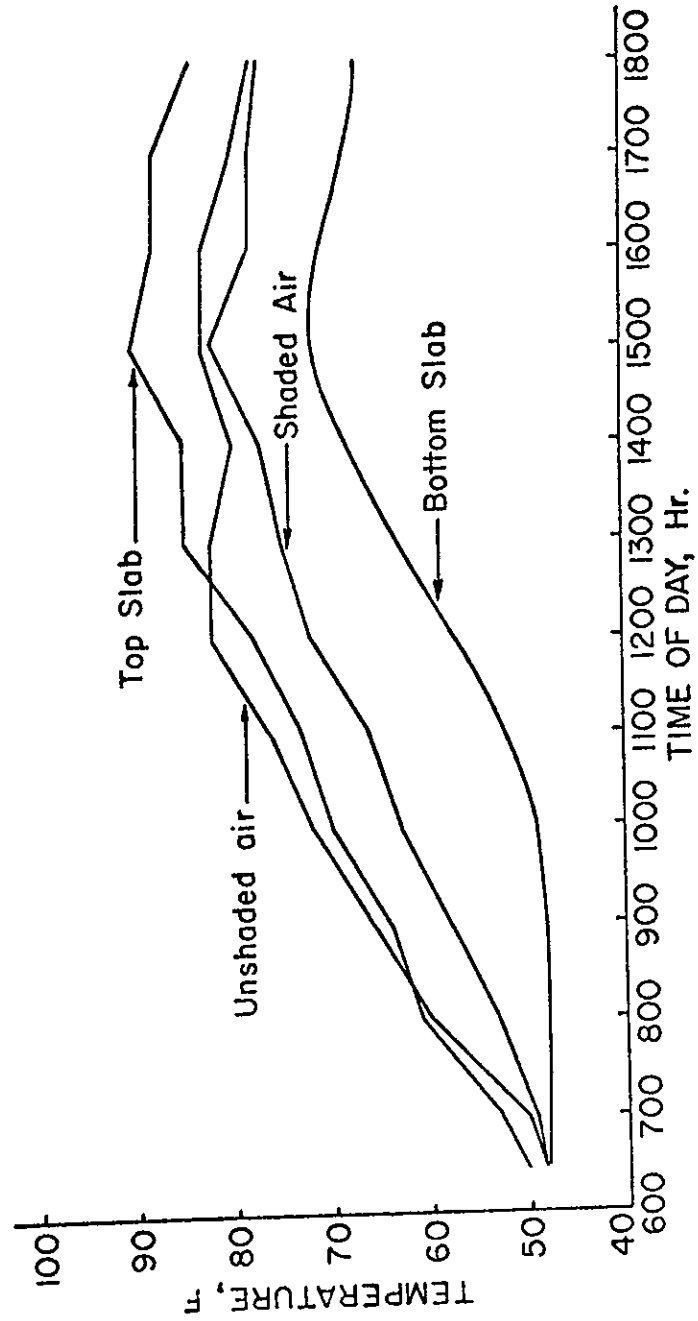
FIG.20- TEMPERATURE RELATIONS

To determine typical corner curling values for the California pavements, exploratory measurements were made at the Sacramento test location. Temperature measured during the daylight hours are given in Figure 20 and corresponding changes in slab corner curl are given in Figure 21. It was assumed that the area of contact between slab and subbase was greatest when the corner curl measurements were minimum. This established zero datum. However, this does not indicate that the slab was in complete contact with the subbase at this time as pavement slabs are usually curled upward to some extent during the entire lifetime of the pavement.

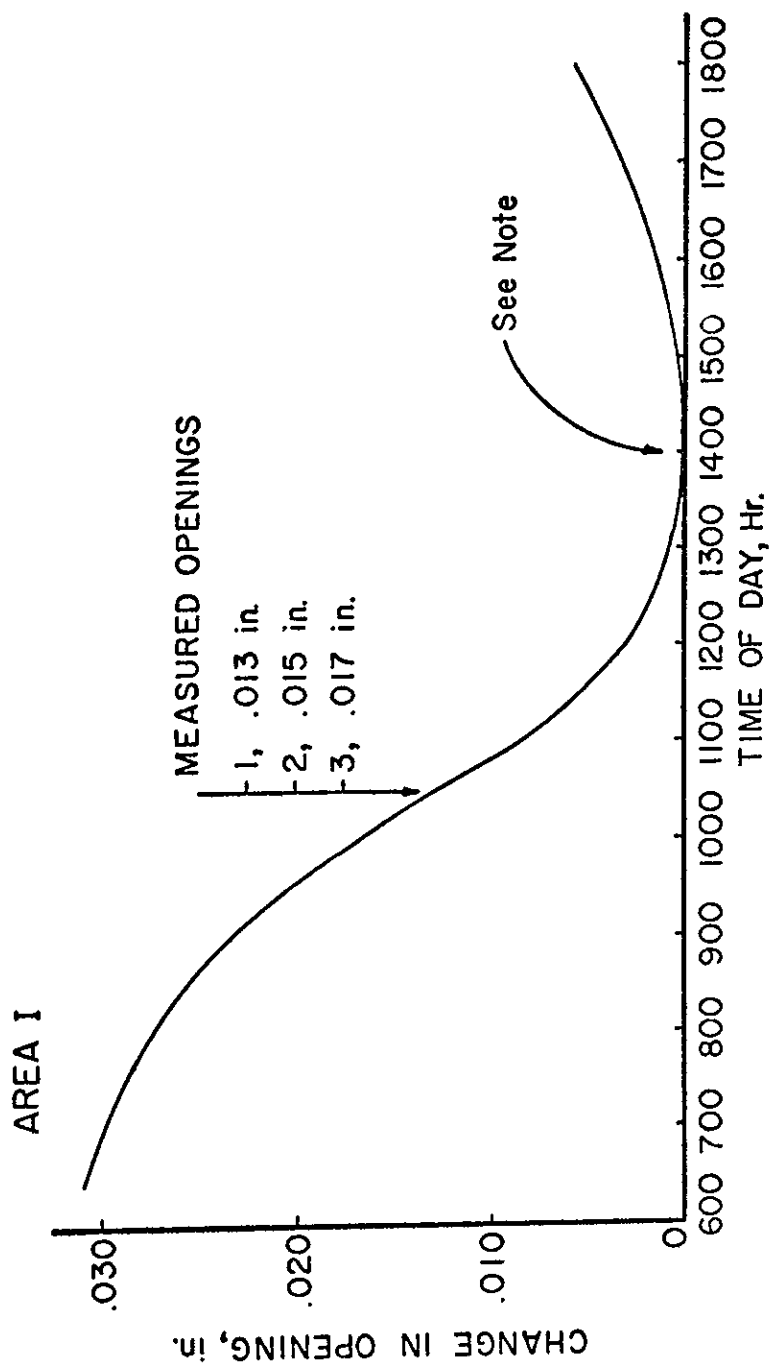
FIG.22- JOINT OPENING

A temperature increase also causes pavement slabs to expand and joint openings to close. Joint openings measured at joint No. 2 (see Table 1) at Sacramento are given in Figure 22.

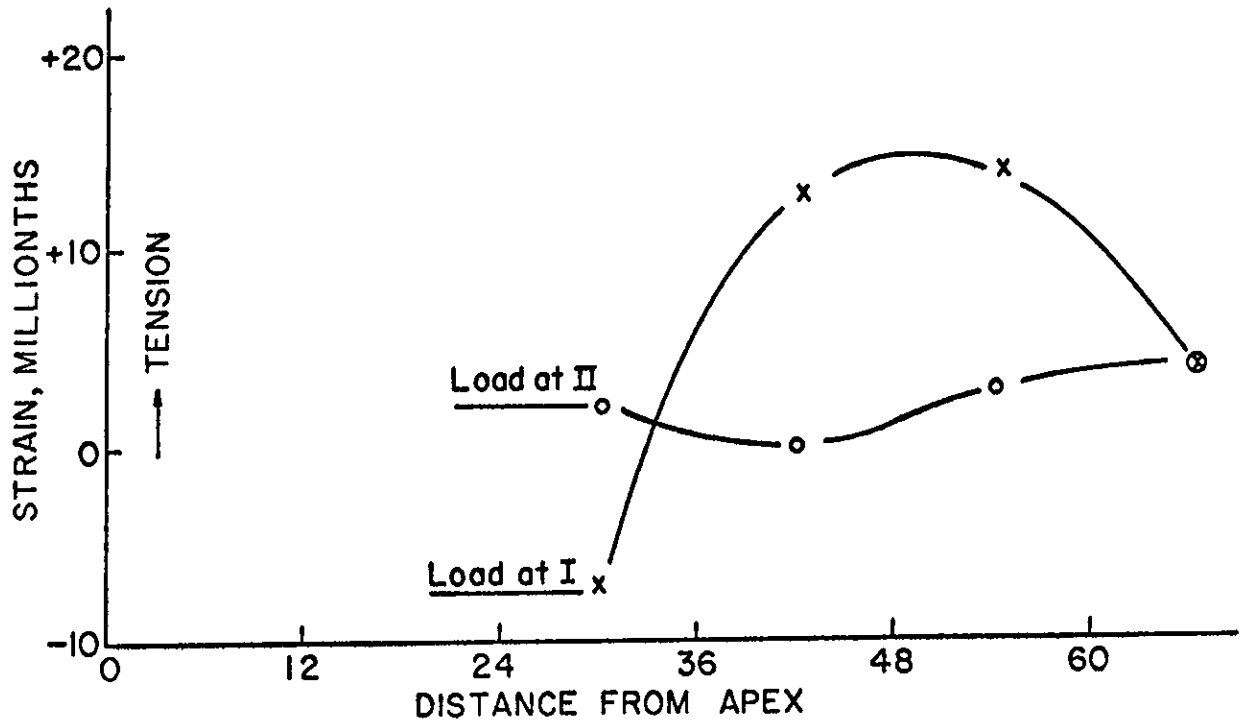
FIG.30- LOAD STRAIN ALONG CORNER BISECTOR

At Truckee, load tests were conducted at 10:00 am on the approach slab and at 1:00 pm on the leave slab. Load-strain results for each load position at Truckee are shown in Figure 30. Maximum strain was located approximately 4 and 5 feet from the apex of the approach and leave corner, respectively. Maximum strains in the morning on the approach slab were approximately 15 micro-inch per inch and maximum strains in the afternoon on the leave slab were approximately 5 micro-inch per inch. These values are about one-half of the maximum strains measured at Sacramento.
